# Best Practices for Fighting and Preventing a Fire in a Wood Pellet Storage Dome or Silo

By John Swaan, Senior Operations Expert, FutureMetrics  
December 4, 2017

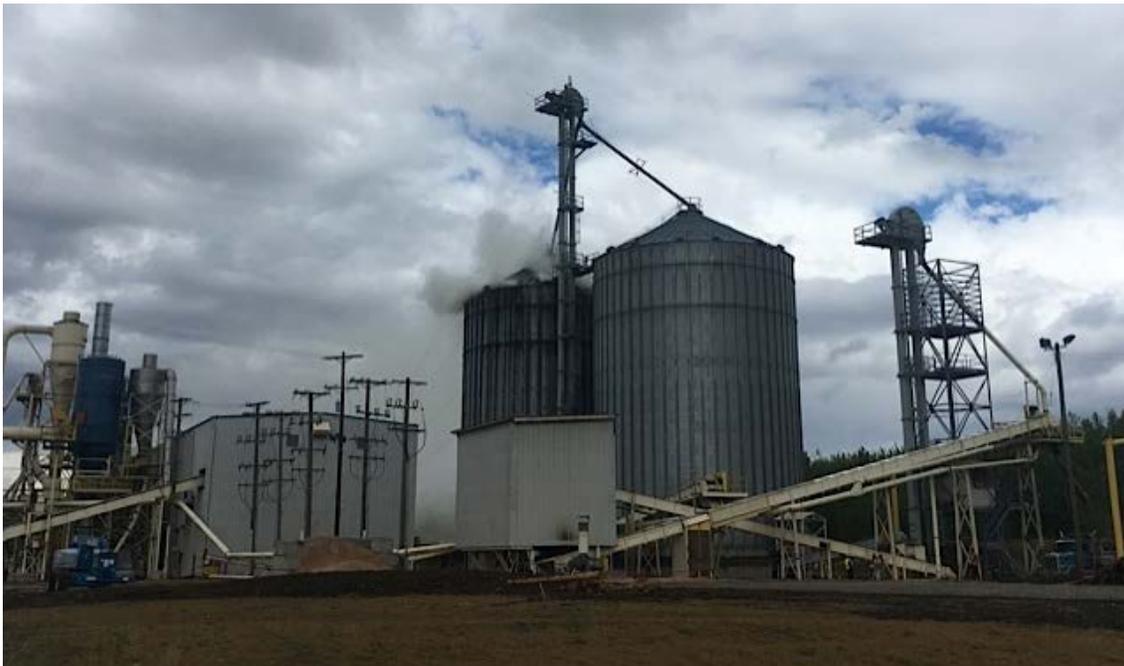
Smoke from smoldering wood pellets inside a PacBio silo containing 3,500 tonnes was first noticed on the evening of Wednesday August 23<sup>rd</sup> (on the left in the photo below).

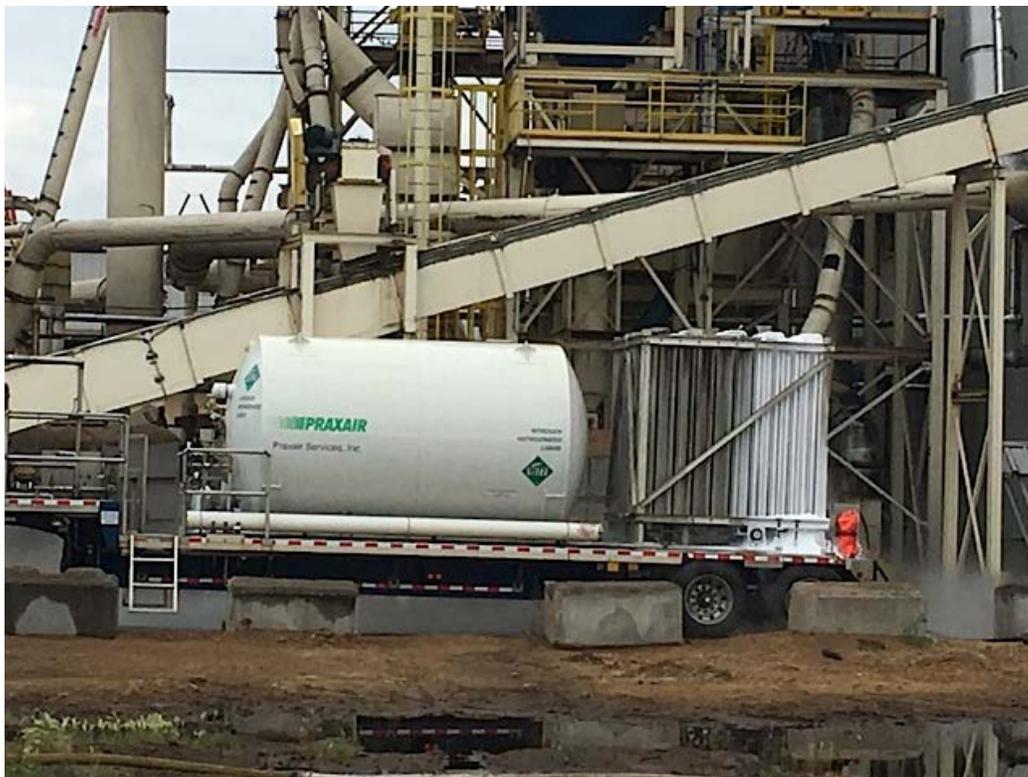
A mobile nitrogen vaporizer and tank unit along other tankers to follow where mobilized from Edmonton, Alberta (the gas and oil industry utilize this type equipment regularly). An engineer from Solid Industrial Solutions was also dispatched to provide onsite assistance with the setup of the nitrogen distribution system and control the nitrogen injection of the flow rate.

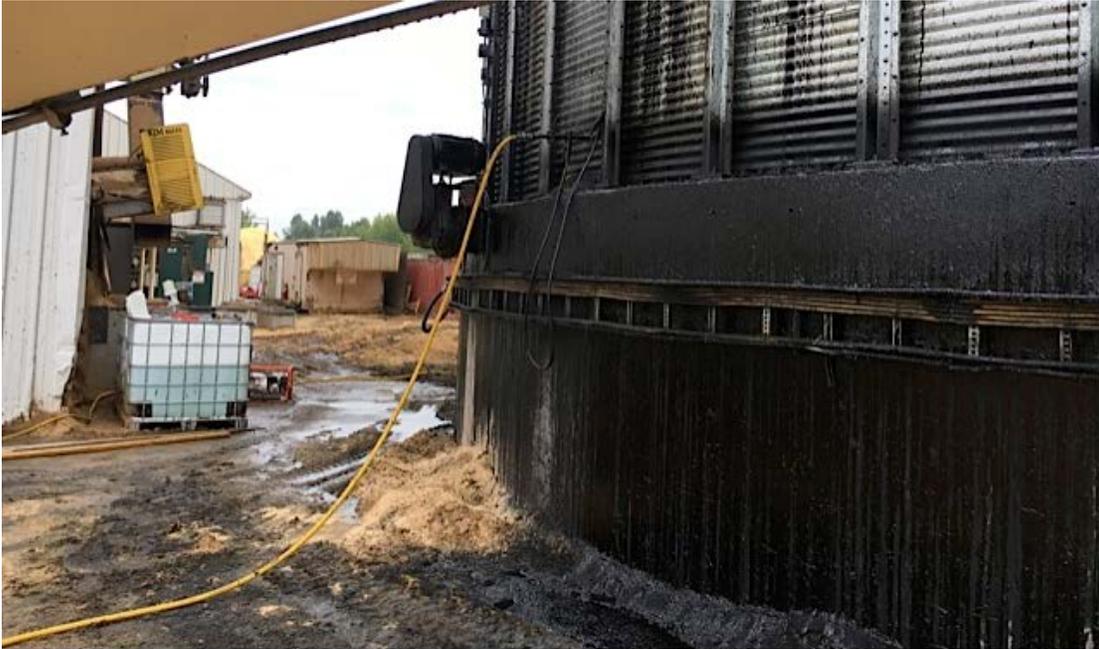
Based on the needed flows and volumes of nitrogen, the PacBio team specified how to fabricate the lances to be driven into the side of the 80-foot (~24 meter) diameter silo. Four lances of ¾ inch (~2 centimeters) steel pipes approximately 20 feet long (~6 meters) with ¼ inch (~6.5 millimeters) holes drilled every 2 inches (~5 centimeters) were fabricated at the machine shop and installed around the bottom of the silo.

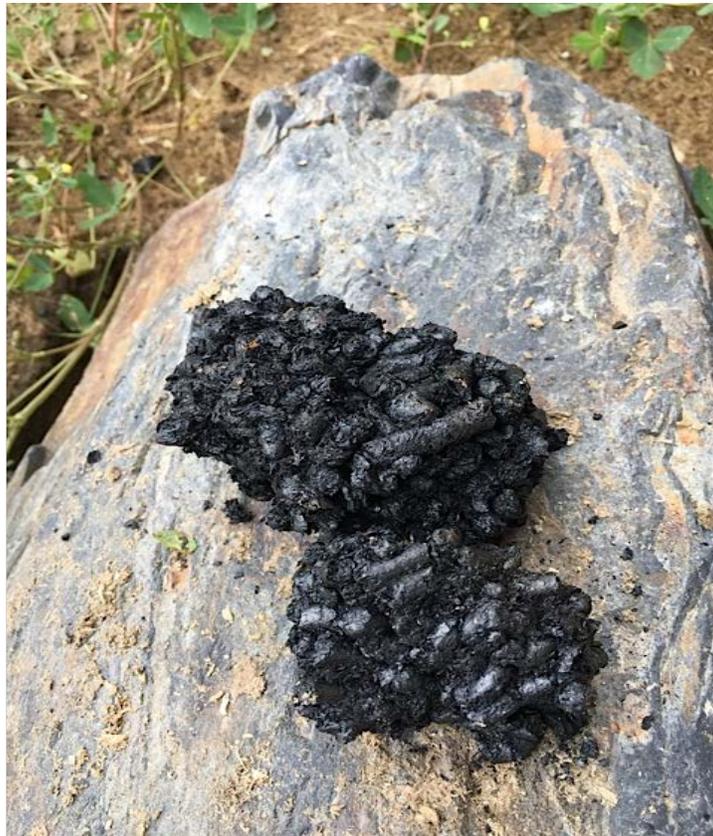
The PacBio team safely handled and evacuated the removed material. The first responders equipped with respiration equipment kept all personnel safe and out of harm's way. Wood pellets and the carbonized clumps coming from the silo were conveyed safely without incident to a flat area away from the plant. Even when meeting atmospheric air there were no issues.

It took approximately 7 days to evacuate the 3500 tons of aborted material, and each truckload was safely moved to a secure area away from other fibre residue stockpiles and deluged with water as they were dumped to make sure there were no residual hot spots.
